Manhole Inspection Summary

Manhole # S17MM_006MH

Location Address: **2510 WARWICK AVE**

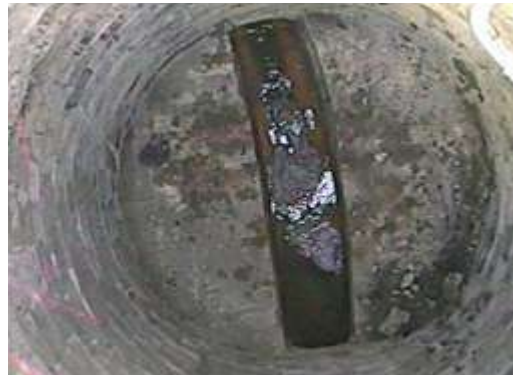
Top View

DEBRIS IN CHANNEL

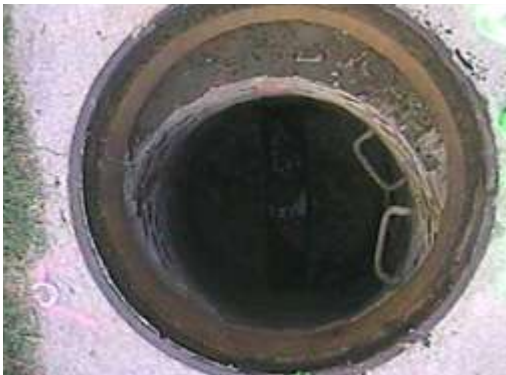
Top View

Frame Offset: **5** (in.) Condition: ☒ Sound ☐ Cracked ☐ Leaks

FRAME OFFSET

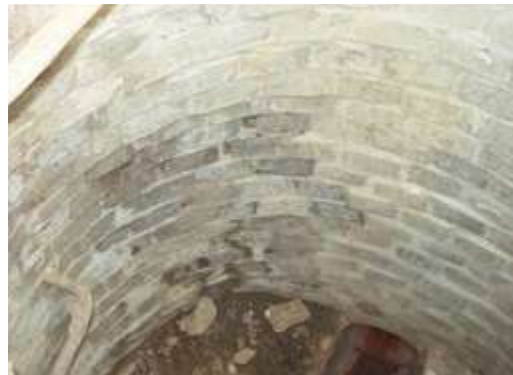
Defect 2

Infiltration: ☐ None ☐ Joint ☐ Cracks ☒ **Mortar** ☐ Roots ☐ Wall

BARREL INFILTRATION AND DEBRIS ON BENCH

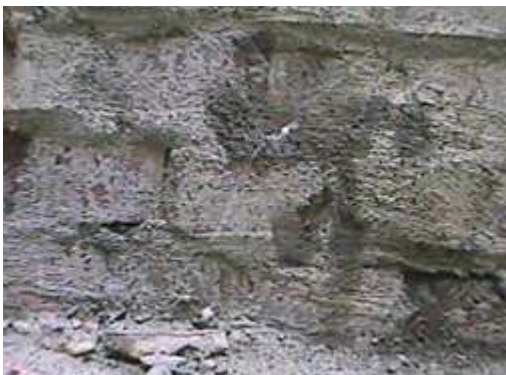
Defect 1

POSSIBLE WEEPER

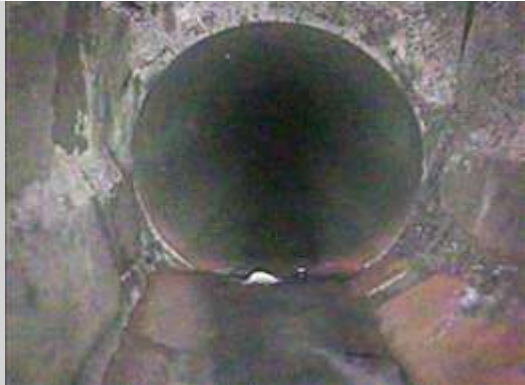
12 O'Clock Outflow

Pipe Height: (in.) Direct
Pipe Material: **Clay** ☐ Pipe Lined
Invert Depth: **7.42** (ft.) Flow Characteristics: **Slow**
Deposits: ☒ None ☐ Mud ☐ Sludge ☐ Debris ☐ Grease
Silt Depth: (in.) Deposits Extent:
Infiltration: **None** Pipe Seal Cond: **Sound**

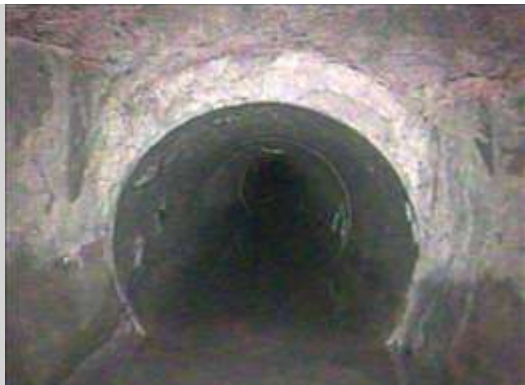
6 O'Clock Inflow

Pipe Height: (in.) Direct
Pipe Material: **Clay** ☐ Pipe Lined
Invert Depth: **7.39** (ft.) Flow Characteristics: **Slow**
Deposits: ☒ None ☐ Mud ☐ Sludge ☐ Debris ☐ Grease
Silt Depth: (in.) Deposits Extent:
Infiltration: **None** Pipe Seal Cond: **Sound**
